CONSTRUCTION FOUNDATION REPORT MISSOURI RIVER FORT PECK  
LAKE MONTANA VOLUME 1 TEXT AND PHOTOS(U) ARMY ENGINEER  
DISTRICT OMAHA NE JAN 83

# CONSTRUCTION FOUNDATION REPORT

### MISSOURI RIVER FORT PECK LAKE, MONTANA

### VOLUME I TEXT AND PHOTOS

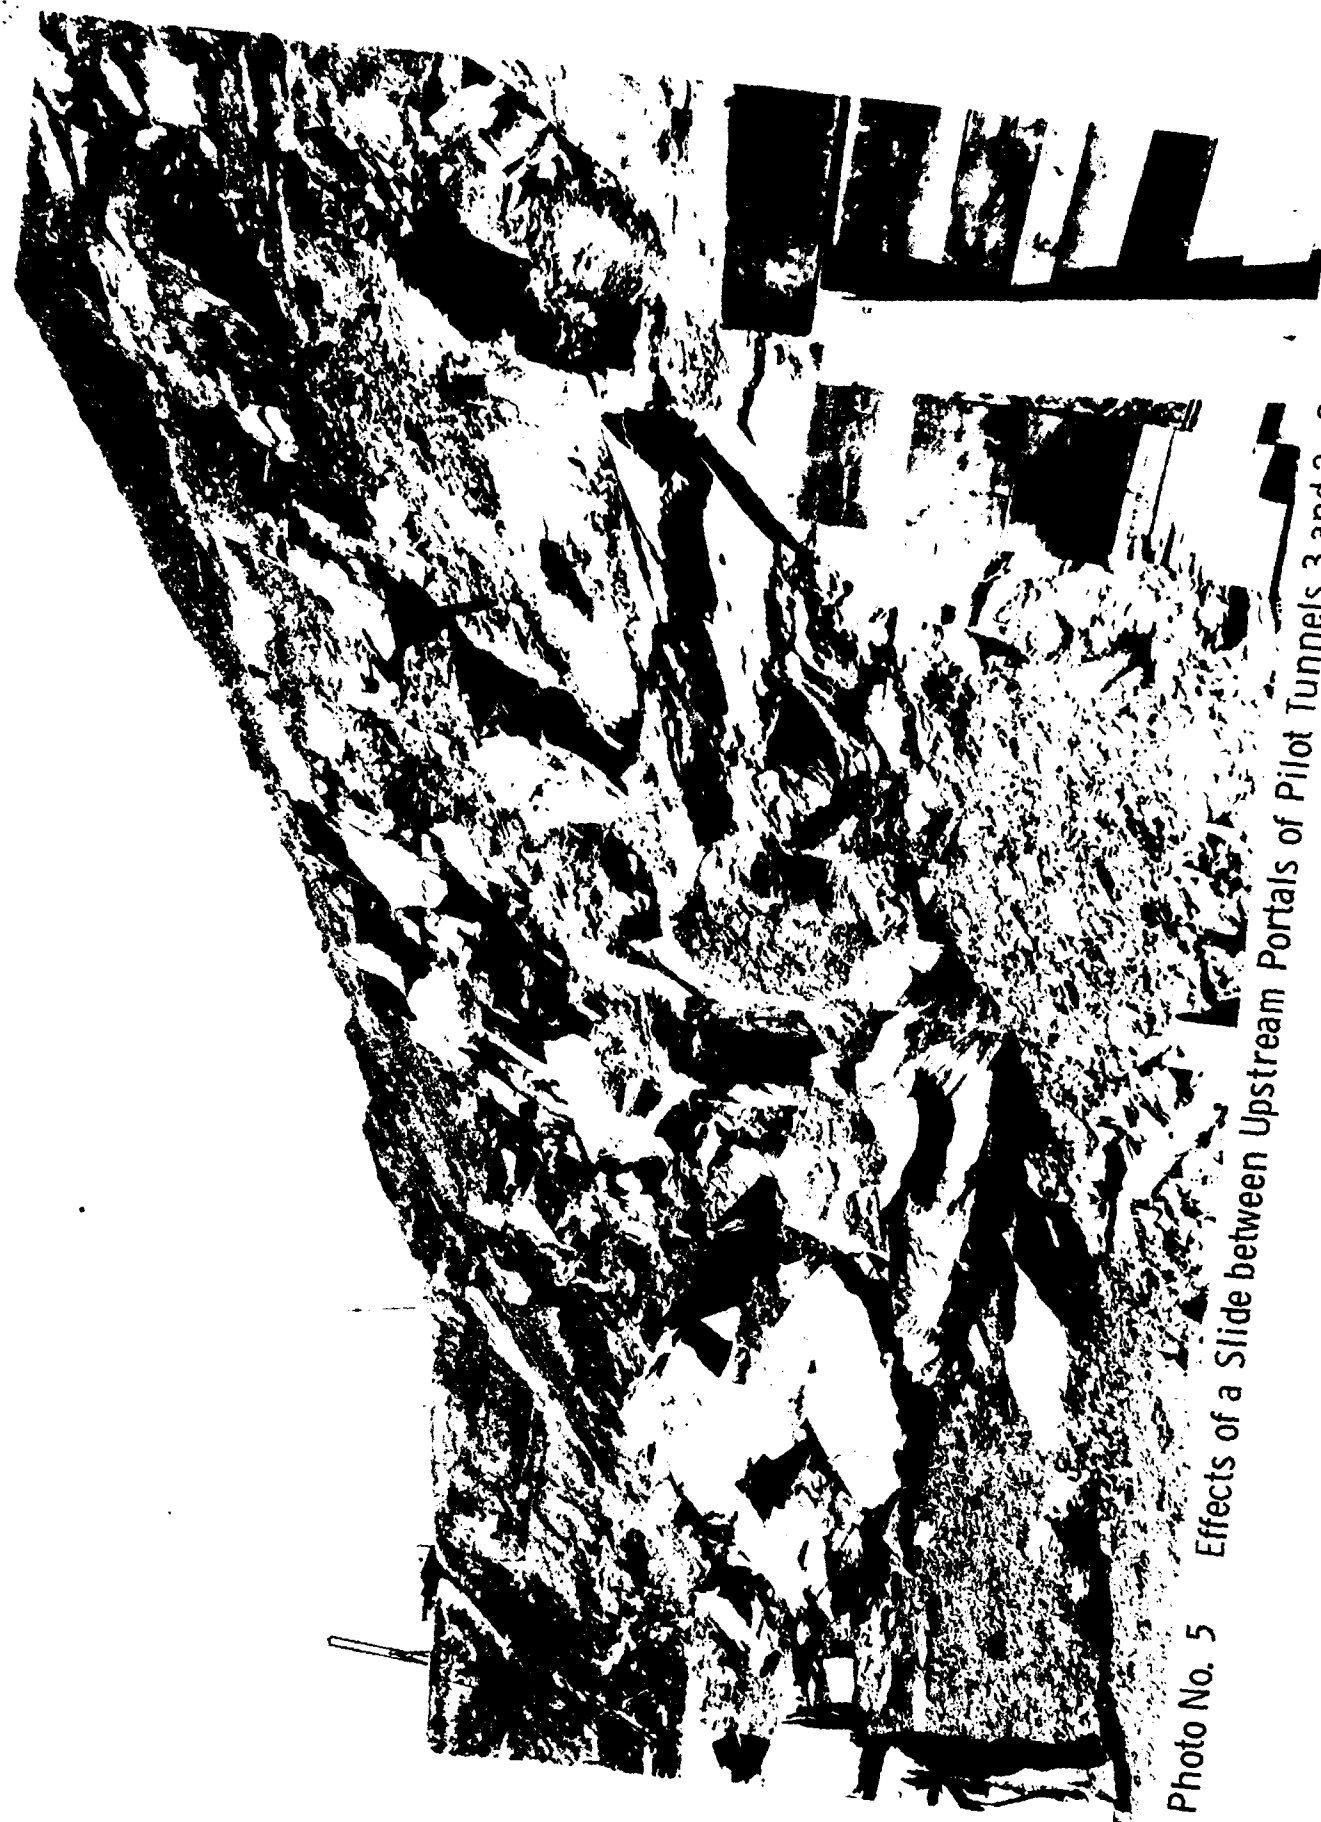
Photo No. 5      Effects of a Slide between Upstream Portals of Pilot Tunnels 3 and 2, September, 1934

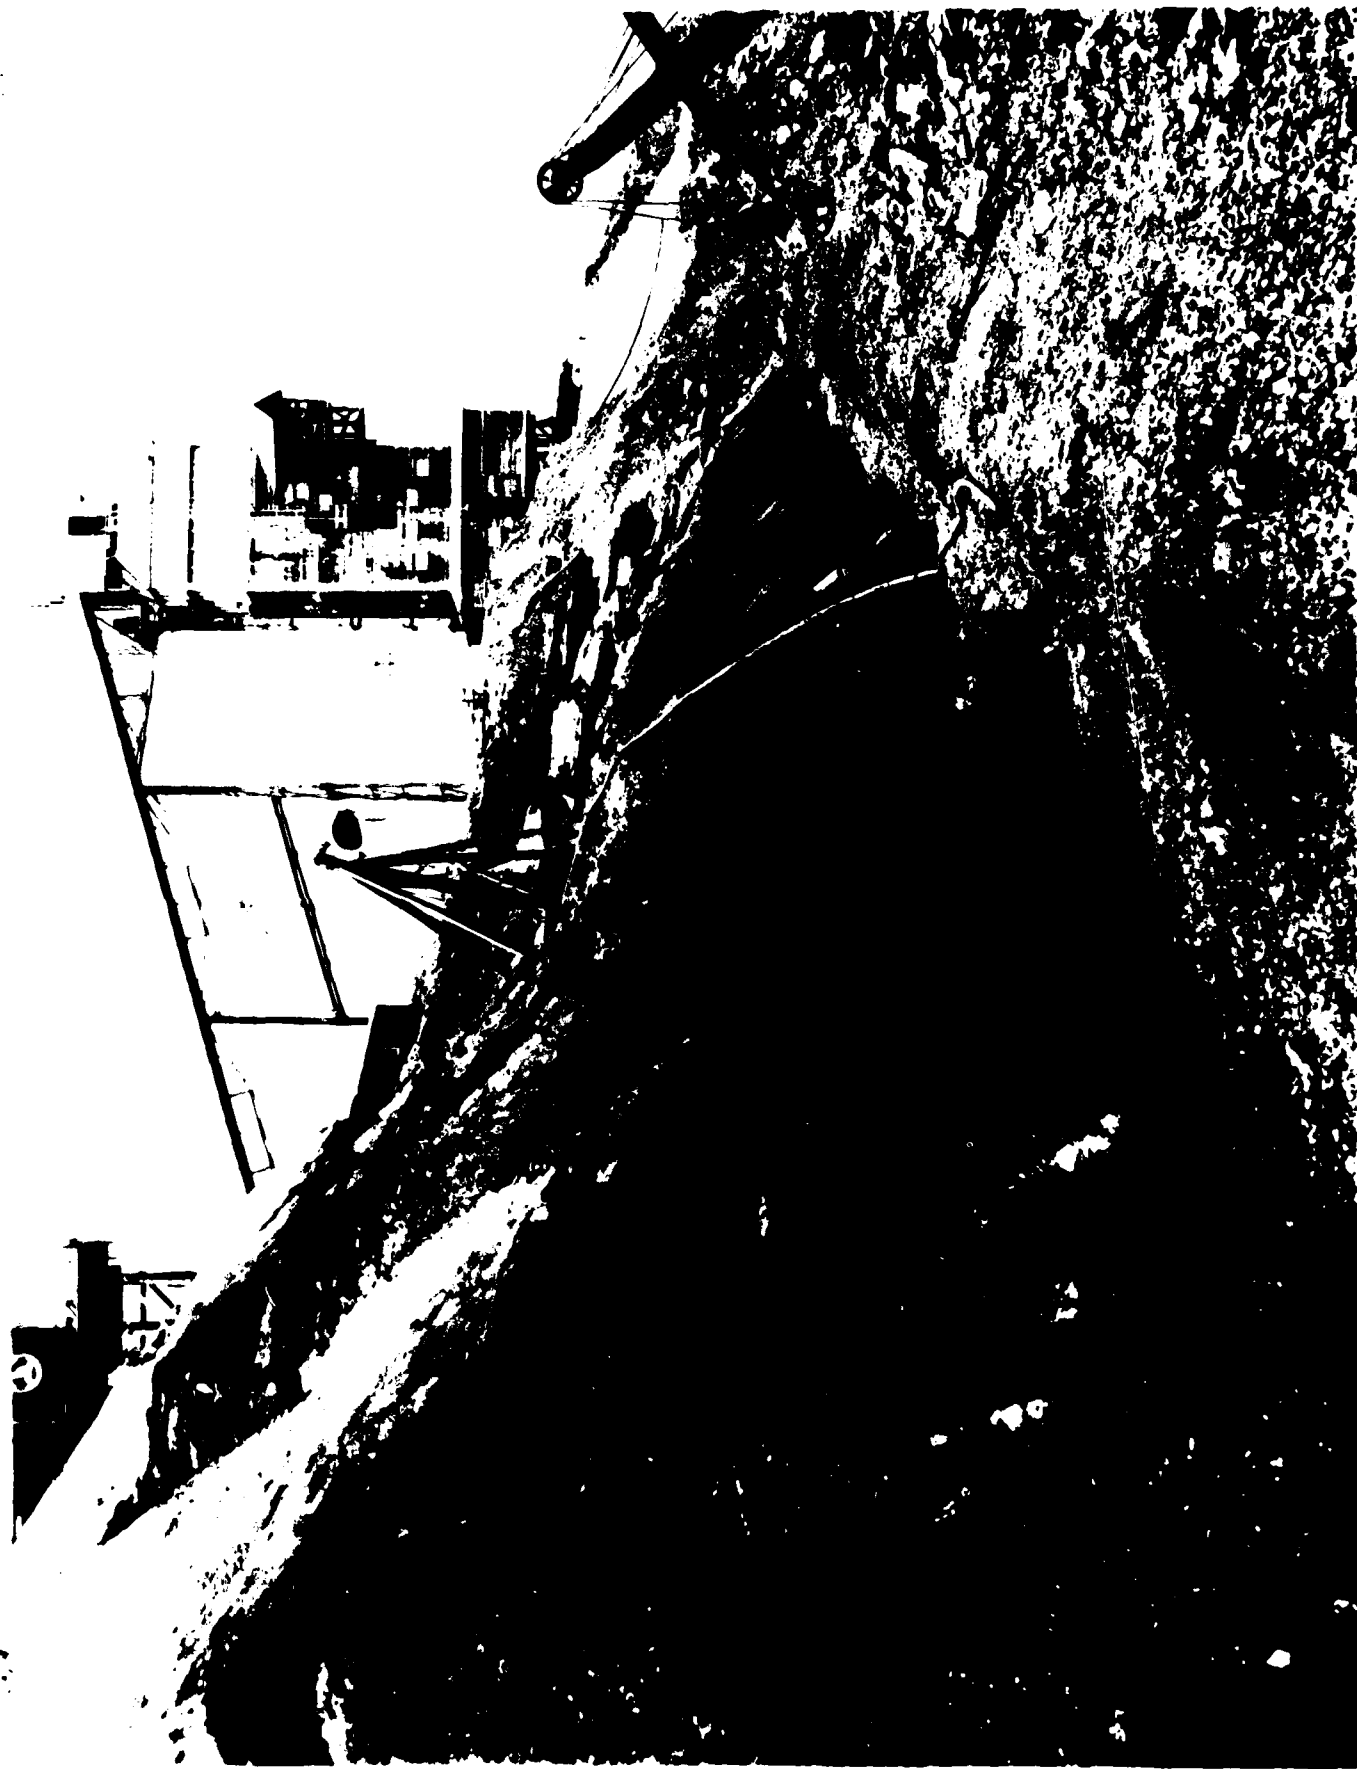
Photo No. 21 Slide in Spillway Channel at Sta. 26+00, looking downstream, July, 1937
